Notice to recyclers regarding booster heater jacket

When recycling the following Mitsubishi Electric models of our Air to Water systems/heat pumps manufactured in United Kingdom between June 2021 and November 2021, please first remove the booster heater jacket which is contaminated with DBP and dispose of this in an environmentally safe way.

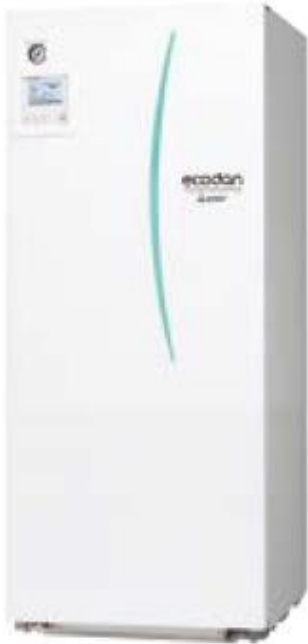
Air to Water Indoor unit (EHST/ERST/EHPT/ERPT/EHGT)

Booster heater jacket
: 1 pcs.

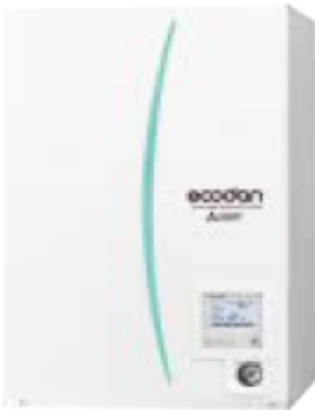
Air to Water Indoor unit (EHSD/ERSD/EHSC/ERSC/EHSE/ERSE/EHPX/ERPX)

Booster heater jacket
: 1 pcs.
